Deliverable 3 – Autonomous Flight Record

2012 UAV Outback Challenge – Search and Rescue Challenge

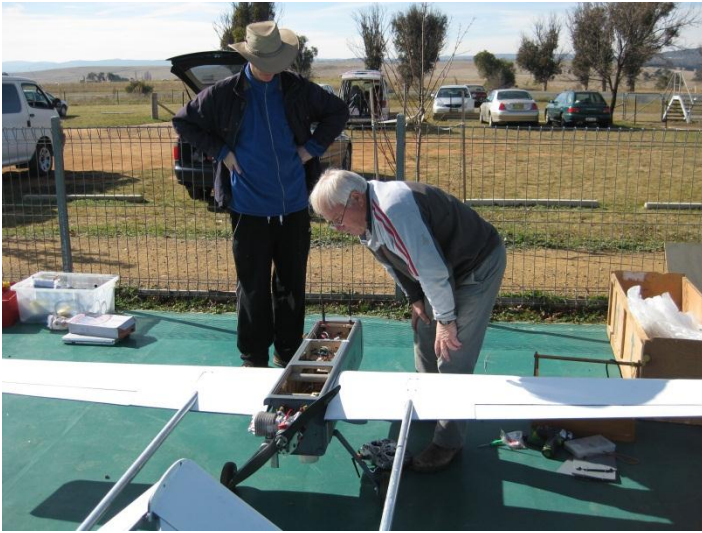
Pre-flight checks

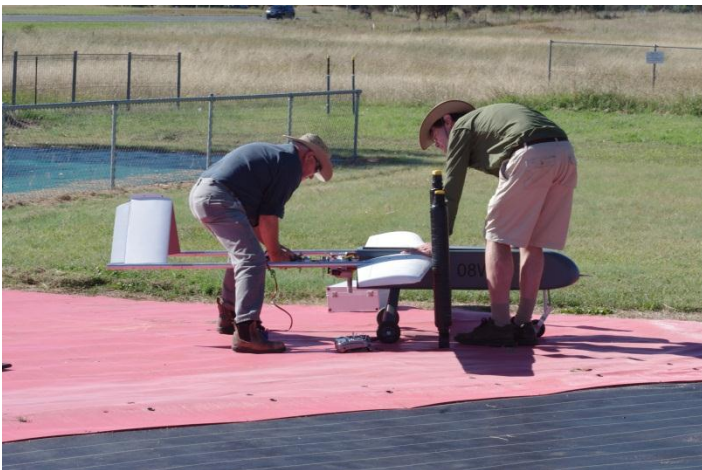
Starting the engine

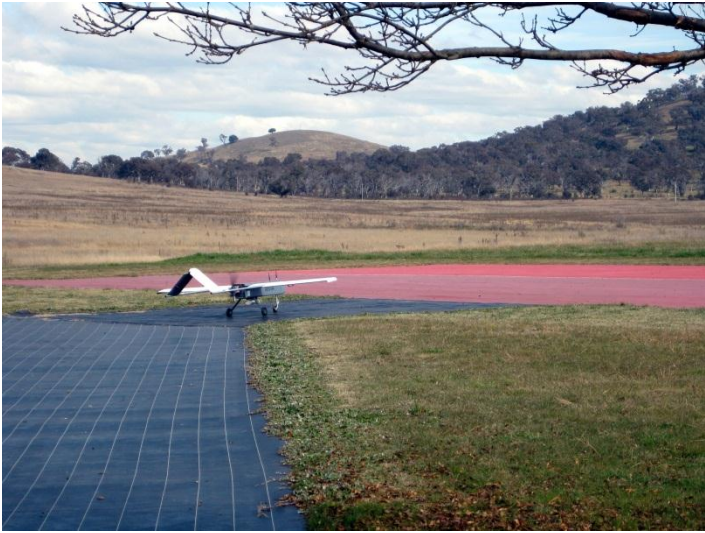
A small white and black aircraft is taxiing on a blue and red runway. The aircraft is positioned on the blue section of the runway, which is bordered by a red section. The background shows a grassy field and hills under a cloudy sky.	<p>Taxiing to the runway for take-off</p>
  A small white and black aircraft is starting its takeoff run on a red runway. The aircraft is positioned on the red section of the runway, which is bordered by a blue section. The background shows a grassy field and hills under a cloudy sky.	<p>Starting the takeoff run</p>
  A small white and black aircraft is taking off from a red runway. The aircraft is positioned on the red section of the runway, which is bordered by a blue section. The background shows a grassy field and hills under a clear sky.	<p>Takeoff</p>

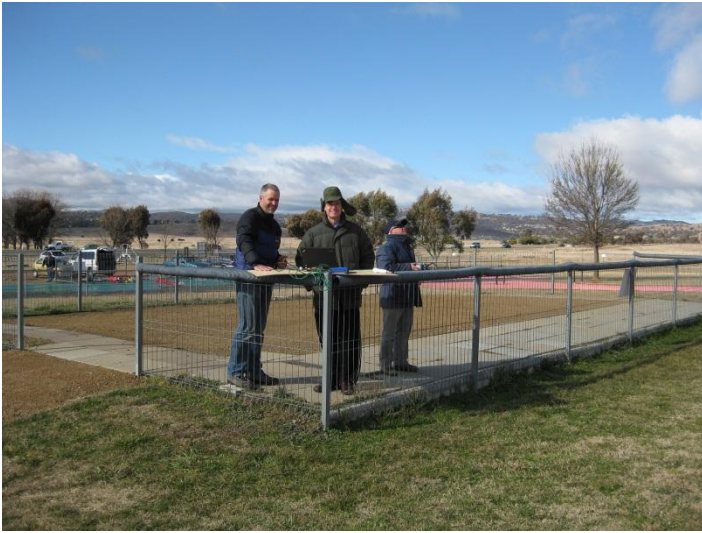
The Ground Station during flight.

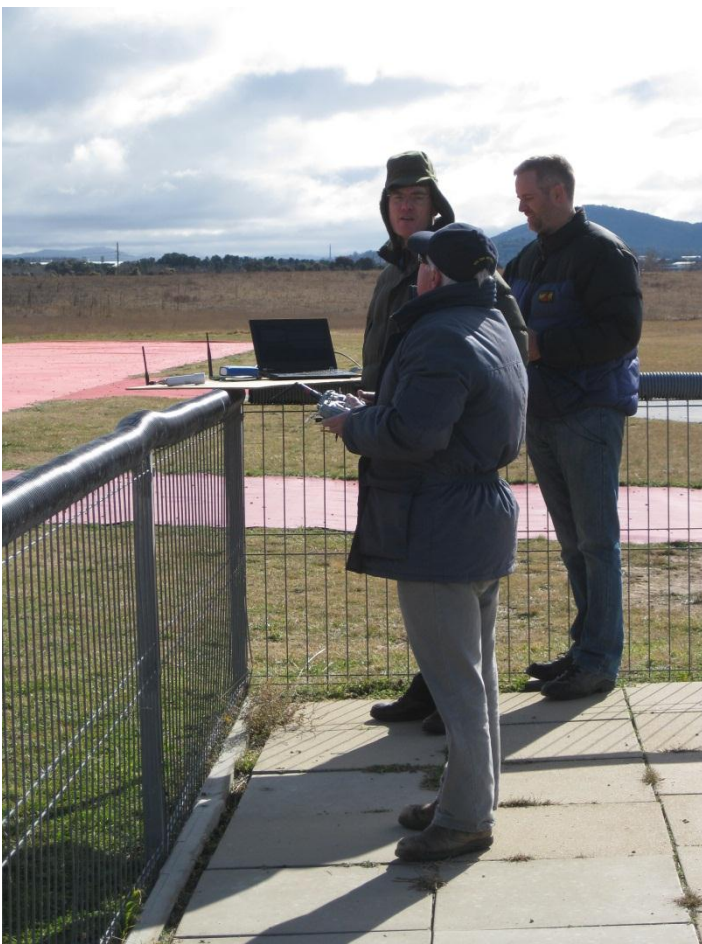
The Ground Station during flight.

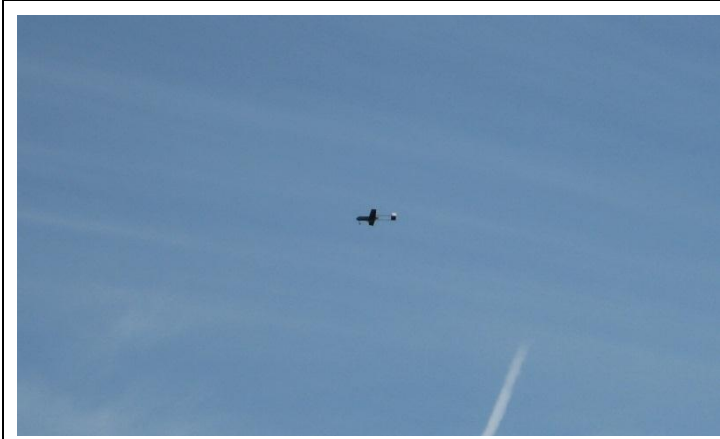
During automated flight

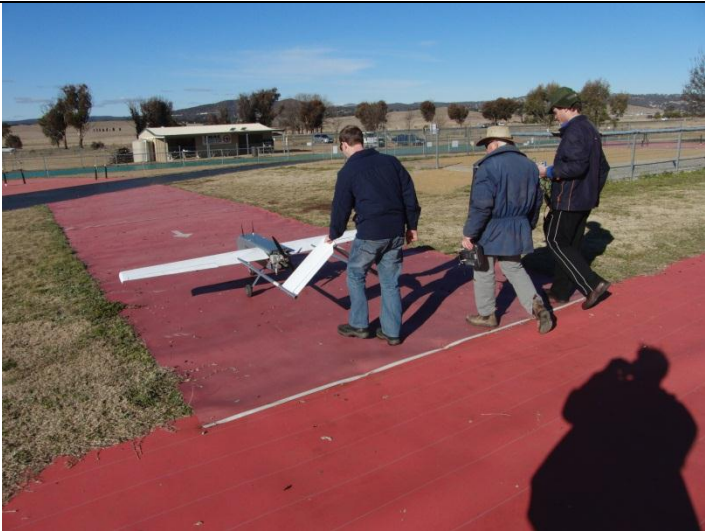
Removing the UAV from the runway after landing
